Manhole Inspection Summary

Manhole # S43KK_061MH

Insp Date: **3/12/08 12:32 PM**

Location Address: **1832 BROADWAY AVE**

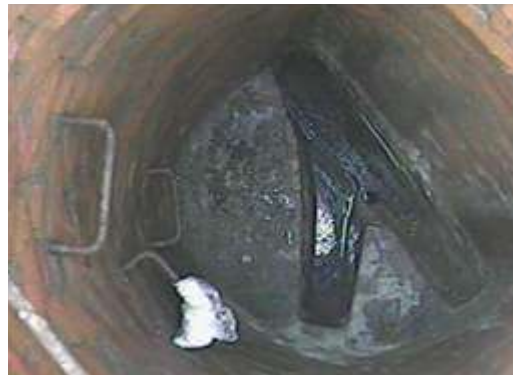
Defect 1

☒ **Evidence Of Surcharge**

Depth: **2.** (ft.) ☐ Active Surcharge Present
25

EVIDENCE OF ACTIVE SURCHARGE

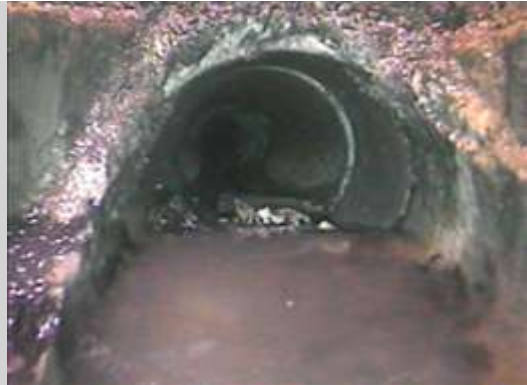
12 O'Clock Outflow

8 in. Circular Gravity Sewer
Pipe Out @ 12 O'Clock

Pipe Height: (in.) Direct
Pipe Material: **Clay** ☐ Pipe Lined
Invert Depth: **9.00** (ft.) Flow Characteristics: **Slow**
Deposits: ☐ None ☐ Mud ☐ Sludge ☒ **Debris** ☐ Grease
Silt Depth: **3** (in.) Deposits Extent: **Light**
Infiltration: **None** Pipe Seal Cond: **Sound**

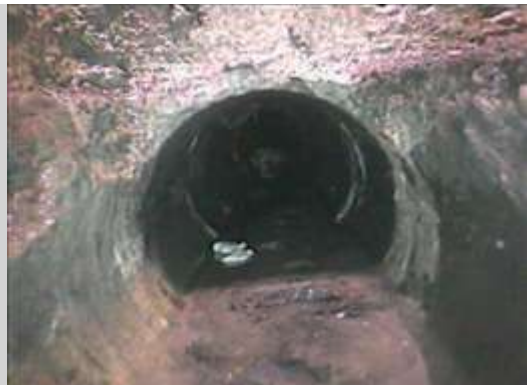
6 O'Clock Inflow

8 in. Circular Gravity Sewer
Pipe In @ 6 O'Clock

Pipe Height: (in.) Direct
Pipe Material: **Clay** ☐ Pipe Lined
Invert Depth: **8.90** (ft.) Flow Characteristics: **Slow**
Deposits: ☐ None ☒ **Mud** ☐ Sludge ☒ **Debris** ☐ Grease
Silt Depth: **2** (in.) Deposits Extent: **Light**
Infiltration: **None** Pipe Seal Cond: **Sound**

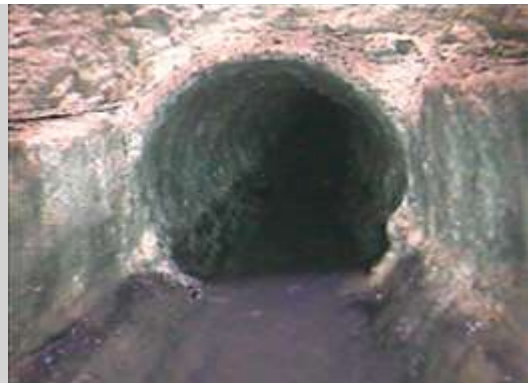
7 O'Clock Inflow

8 in. Circular Gravity Sewer

Pipe In @ 7 O'Clock

Deposits: ☒ None ☐ Mud ☐ Sludge ☐ Debris ☐ Grease

Infiltration: **None** Pipe Seal Cond: **Sound**
